**Flood Control Project Maintenance
Levee Inspections**

Fall 2019 Levee Maintenance Deficiency Summary Report

Sacramento River Basin

Yolo County Department of Natural Resources

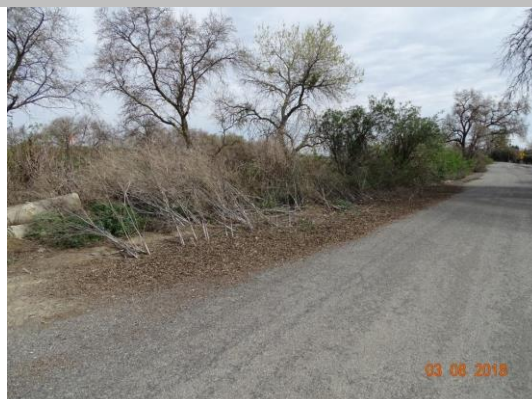
Photo 1 of 2 : FA_2019_NA0021_351_23_20190829_00016.jpg

LM Start	0.03	Rating **	U	Issue No.	23
LM End	0.07	Issue Type +	Ma	Location *	WS
Category	Earthen Levee			GPS Latitude/Longitude	
				Start	End
Item	Vegetation			38.720892°	38.721020°
				-121.810421°	-121.809792°
DWR ID	DWR_NA0021_01_s_2017_23				
Comment Code					
V2 : Remove the wild growth other than native grasses from the levee slopes.					
Inspector Comment					
There is thick vegetation on waterside slope blocking visibility.

Wild vegetation on the waterside levee slope, Spring 2018.

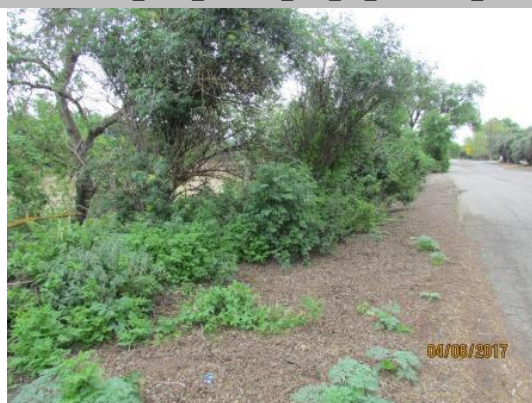
Photo 2 of 2 : FA_2019_NA0021_351_23_20190829_00017.jpg

Wild vegetation on waterside levee slope, Spring 2017.

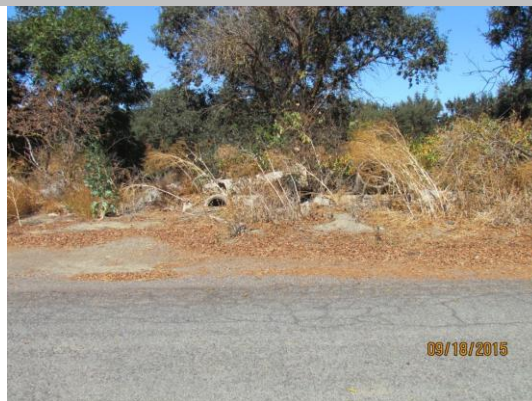
Photo 1 of 1 : FA_2019_NA0021_351_15_20190829_00007.jpg

LM Start	0.03	Rating **	M	Issue No.	15
LM End	0.03	Issue Type +	Ma	Location *	WS
Category	Earthen Levee			GPS Latitude/Longitude	
				Start	End
Item	Encroachments			38.720895 °	38.720895 °
				-121.810408 °	-121.810408 °
DWR ID	DWR_NA0021_01_f_2015_15				
Comment Code					
DE : Debris					
Inspector Comment					
Concrete pipes are located on the waterside slope.

View of the debris on the waterward side of the levee. Fall 2015.

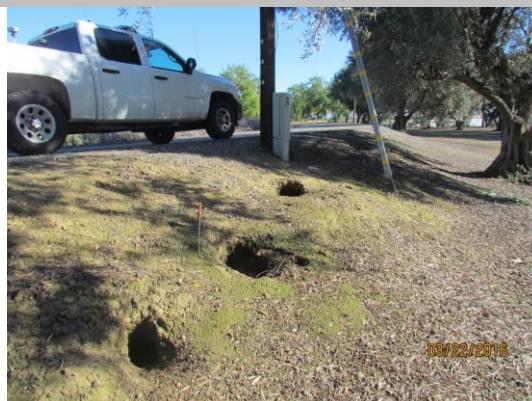
Photo 2 of 3 : FA_2019_NA0021_351_16_20190829_00009.jpg

LM Start	0.19	Rating **	U	Issue No.	16 (cont)	
LM End	0.19	Issue Type +	Ma	Location *	LS	
Category	Earthen Levee			GPS Latitude/Longitude		
				Start		End
Item	Animal Control			38.721536 °		38.721536 °
				-121.807711 °		-121.807711 °
DWR ID	DWR_NA0021_01_s_2015_16					
Comment Code						
A3 : No rodents visible, but rodent burrows visible; need to backfill and compact or grout burrows.						
Inspector Comment

View of the rodent holes on the landward side of the levee looking downstream. Spring 2016.

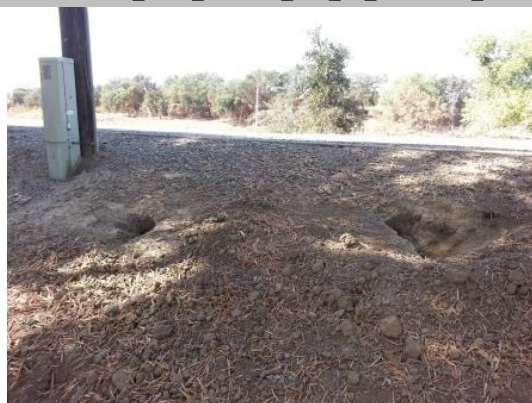
Photo 3 of 3 : FA_2019_NA0021_351_16_20190829_00010.jpg

View of rodent holes on landside slope. Fall 2016.

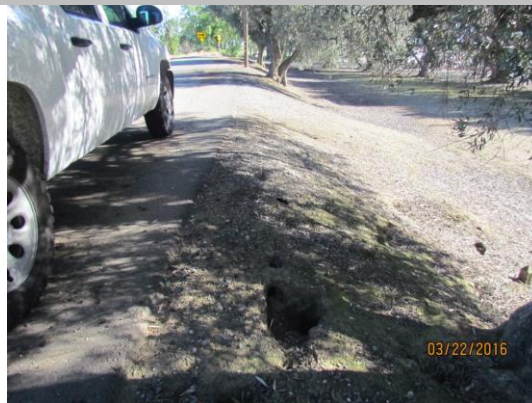
Photo 1 of 2 : FA_2019_NA0021_351_7_20190829_00003.jpg

LM Start	0.20	Rating **	M	Issue No.	7
LM End	0.20	Issue Type +	Ma	Location *	LS
Category	Earthen Levee			GPS Latitude/Longitude	
				Start	End
Item	Animal Control			38.721683 °	38.721683 °
				-121.807532 °	-121.807532 °
DWR ID	DWR_NA0021_01_s_2016_7				
Comment Code					
A3 : No rodents visible, but rodent burrows visible; need to backfill and compact or grout burrows.					
Inspector Comment

Perspective view of the rodent hole on the landward side of the levee looking downstream. Spring 2016.

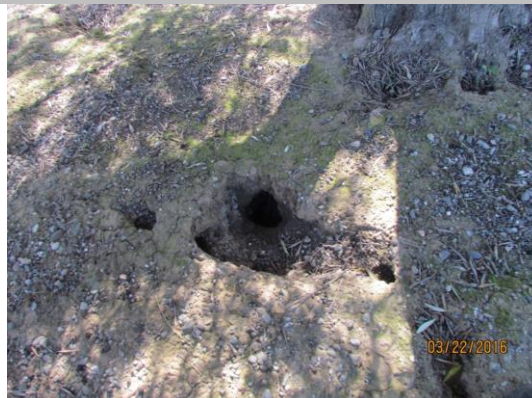
Photo 2 of 2 : FA_2019_NA0021_351_7_20190829_00004.jpg

LM Start	0.20	Rating **	M	Issue No.	7 (cont)	
LM End	0.20	Issue Type +	Ma	Location *	LS	
Category	Earthen Levee			GPS Latitude/Longitude		
				Start		End
Item	Animal Control			38.721683 °		38.721683 °
				-121.807532 °		-121.807532 °
DWR ID	DWR_NA0021_01_s_2016_7					
Comment Code						
A3 : No rodents visible, but rodent burrows visible; need to backfill and compact or grout burrows.						
Inspector Comment

Animal hole is close to the shoulder of the levee. Spring 2016.

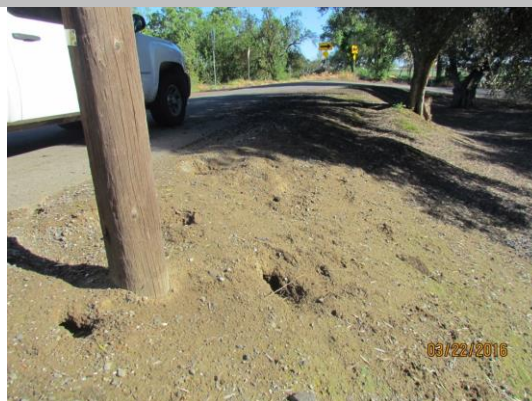
Photo 1 of 1 : FA_2019_NA0021_351_8_20190829_00005.jpg

LM Start	0.22	Rating **	M	Issue No.	8
LM End	0.22	Issue Type +	Ma	Location *	LS
Category	Earthen Levee			GPS Latitude/Longitude	
				Start	End
Item	Animal Control			38.721876 °	38.721876 °
				-121.807393 °	-121.807393 °
DWR ID	DWR_NA0021_01_s_2016_8				
Comment Code					
A3 : No rodents visible, but rodent burrows visible; need to backfill and compact or grout burrows.					
Inspector Comment

View of the rodent holes on the landward side of the levee looking downstream. Spring 2016.

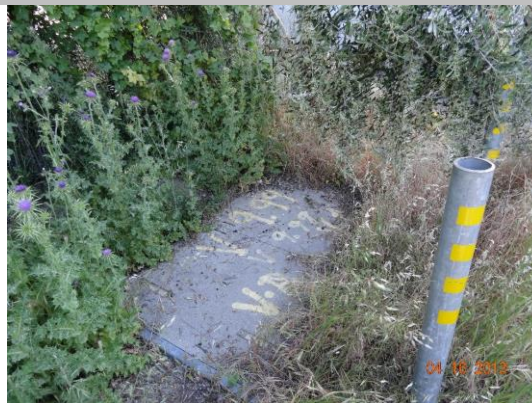
Photo 2 of 3 : UCIP_FA_2019_39855_69554.jpg

Service vault located on landward toe near gate access gate.

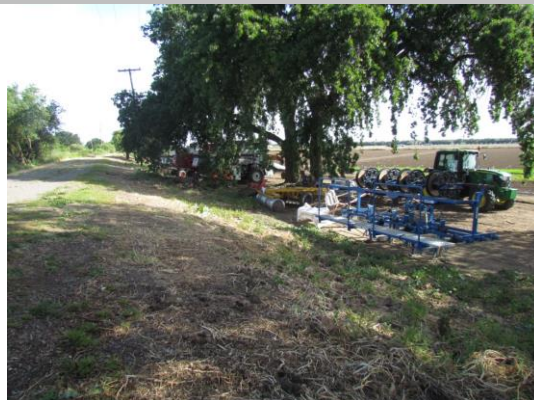
Photo 2 of 2 : FA_2019_NA0021_351_18_20190829_00012.jpg

View of equipment on the landward side of the levee looking downstream. Spring 2015.

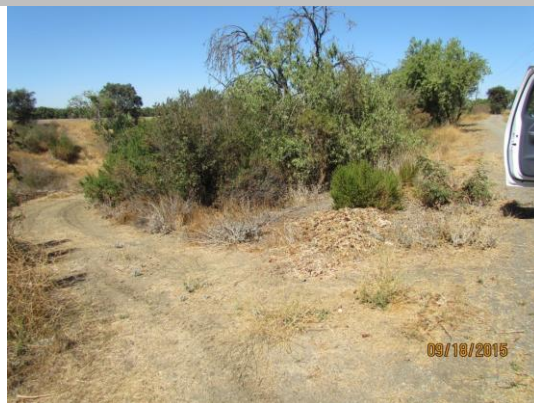
Photo 1 of 3 : FA_2019_NA0021_351_22_20190829_00013.jpg

LM Start	0.27	Rating **	M	Issue No.	22
LM End	0.27	Issue Type +	En	Location *	WS
Category	Earthen Levee			GPS Latitude/Longitude	
				Start	End
Item	Encroachments			38.722620 °	38.722620 °
				-121.806958 °	-121.806958 °
DWR ID	DWR_NA0021_01_f_2015_22				
Comment Code					
RA : Ramp					
Inspector Comment					
There is an unauthorized vehicle ramp by owner on the waterside slope.

Perspective view of the trail on the waterward side of the levee looking downstream. Fall 2015.

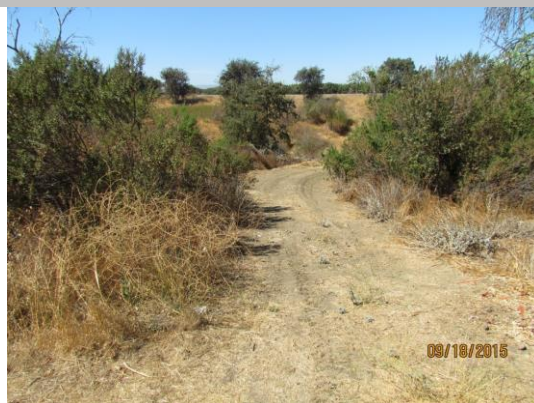
Photo 2 of 3 : FA_2019_NA0021_351_22_20190829_00014.jpg

View of the trail on the waterward side of the levee. Fall 2015.

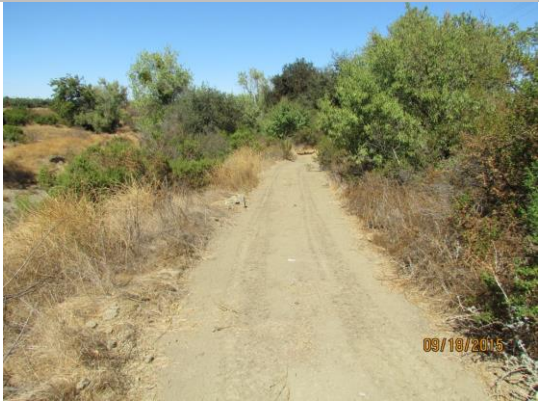
Photo 3 of 3 : FA_2019_NA0021_351_22_20190829_00015.jpg

The trail seems to be an access point that leads down to Cache Creek.
Fall 2015.
